From: [Miller, Gary](#)
To: [Owens, Rock \(CAO\)](#)
Cc: [Jacquelyn Young](#); [Uttley, Sarah \(CAO\)](#); [Allen, Bob \(PCS\)](#); [Sanchez, Carlos](#); [Foster, Anne](#); [Linda Henry](#); [Garry McMahan](#); [Leah Oberlin \(loberlin@poha.com\)](#); [angela.sunley@glo.texas.gov](#); [Walters, Donn](#)
Subject: RE: SJRWP Safety Req
Date: Thursday, March 31, 2016 10:10:57 AM
Attachments: [SJRWP Texans Together Questions 2-25-16.docx](#)
[image002.png](#)

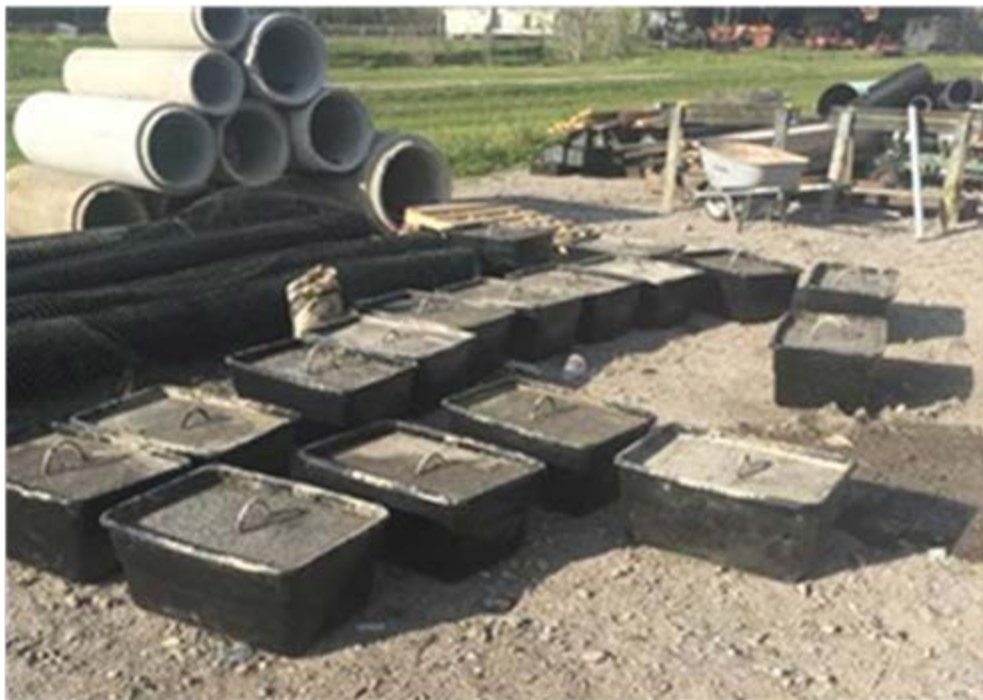
FYI, below is a picture of the buoy anchors that are ready for the buoy delivery.

FYI, Jackie told me about the loose buoy and the PRPs are sending a person to the site today to check on the buoys and their attachments. Also, the current buoys are temporary while waiting on the permanent lighted buoys which the PRPs have backordered. The permanent buoys will be anchored by concrete blocks that have been poured. The estimated buoy delivery from the manufacturer is now April 13, 2016, with fabrication, then starting deployment on April 19, 2016. The current temporary buoys will be removed when the permanent lighted buoys are installed.
